Manhole Inspection Summary

Manhole # S35GG1017MH

Insp Date: **1/25/07 9:59 AM**

Location Address: **4004 GREENWAY**

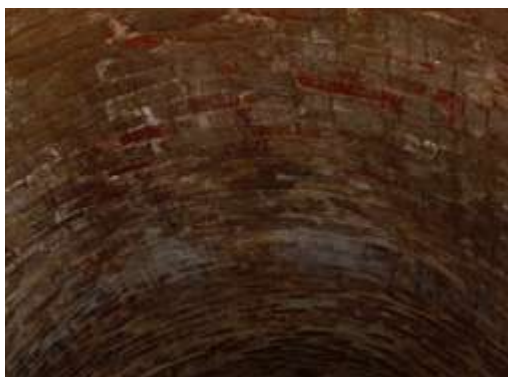
Defect

Infiltration: ☐ None ☐ Joint ☐ Cracks ☐ Mortar ☐ Roots ☒ **Wall**

INFILTRATION MH

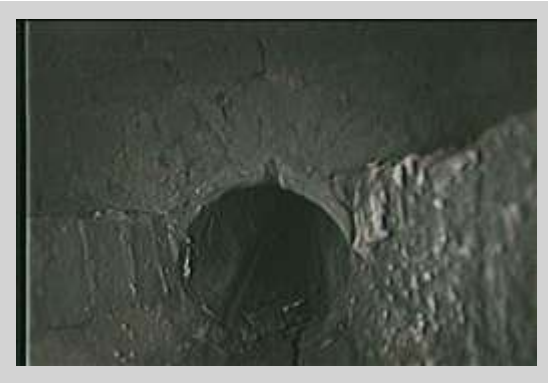
Pipe Out @ 12 O'Clock

Infiltration: **Evidence** Pipe Seal Cond: **Unknown**

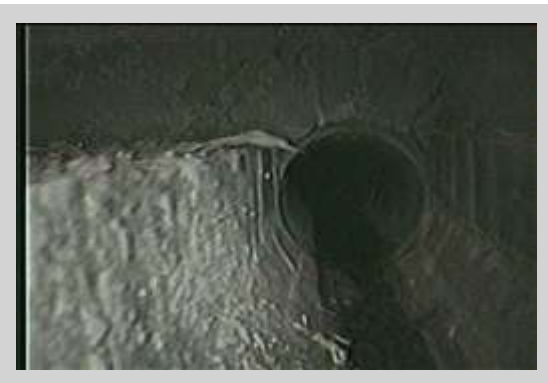
Pipe In @ 6 O'Clock

Deposits: ☐ None ☒ **Mud** ☐ Sludge ☐ Debris ☐ Grease

Silt Depth: **0** (in.) Deposits Extent: **Light**

Infiltration: **Evidence** Pipe Seal Cond: **Cracked**

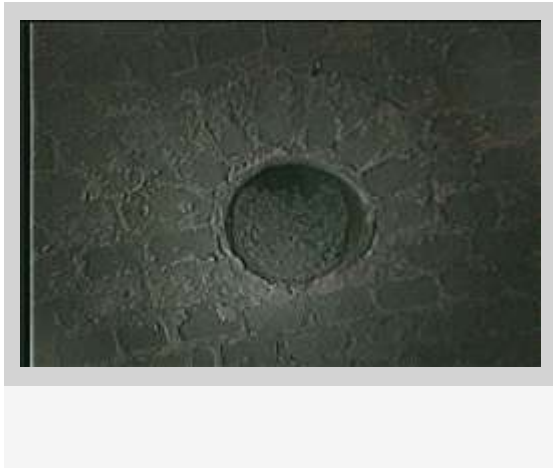
Pipe In @ 9 O'Clock

Infiltration: **Evidence**

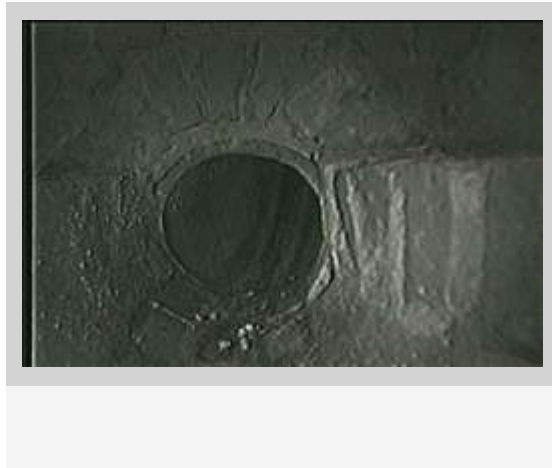
Drop In @ 9 O'Clock

Drop: **Outside** Rod and Bar

Drop Condition: **Open**
